CRITICAL AREAS REPORT

Cougar Ridge Estate - Bellevue, WA

Prepared for: Vadim Scherbinin, Apex Elite Homes

October 2016

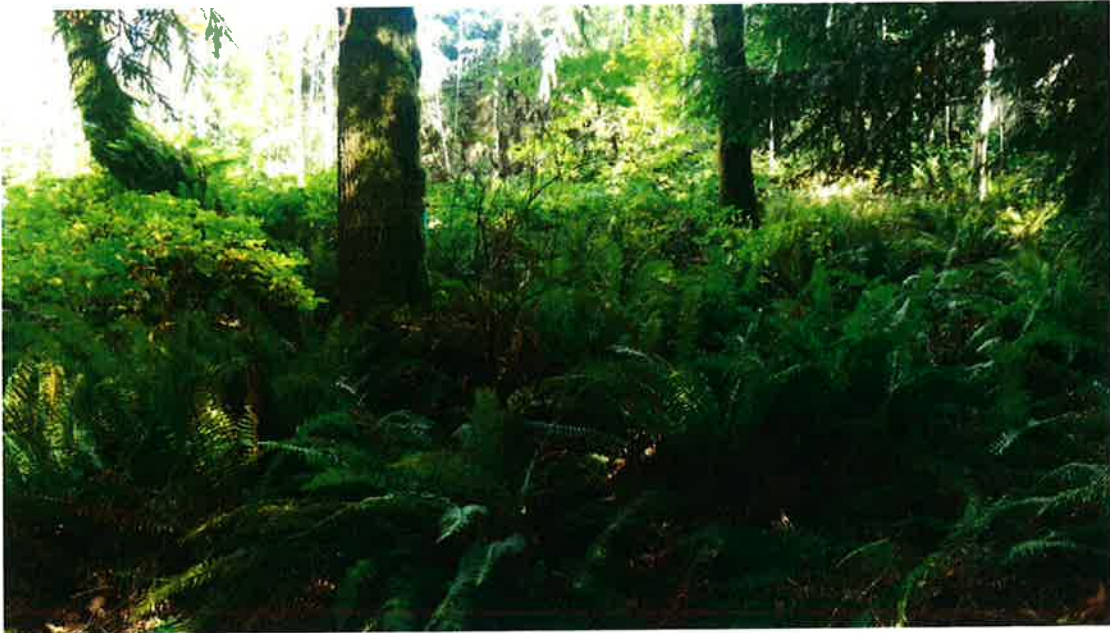
Figure 2: Densely vegetated portion of the parcel

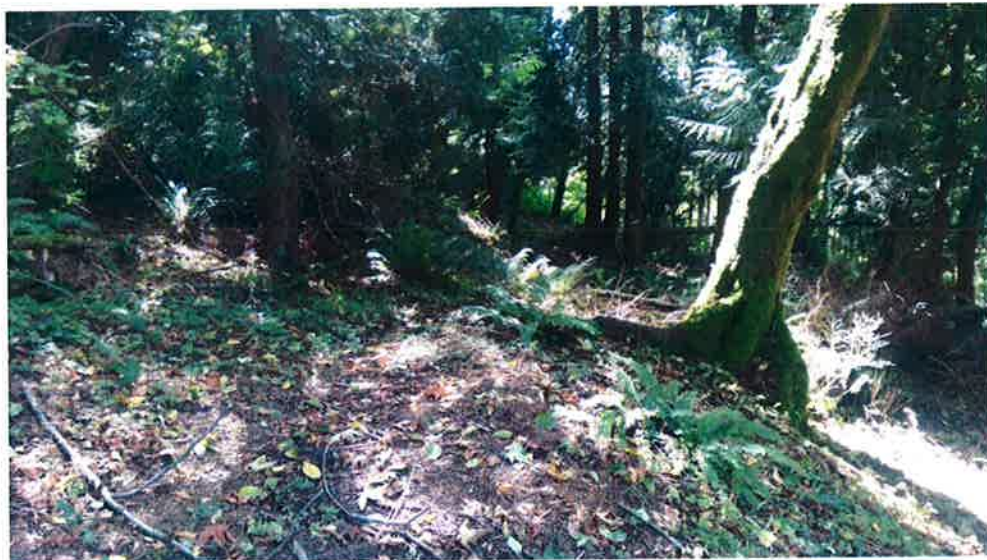
Figure 3: Typical conditions on site.

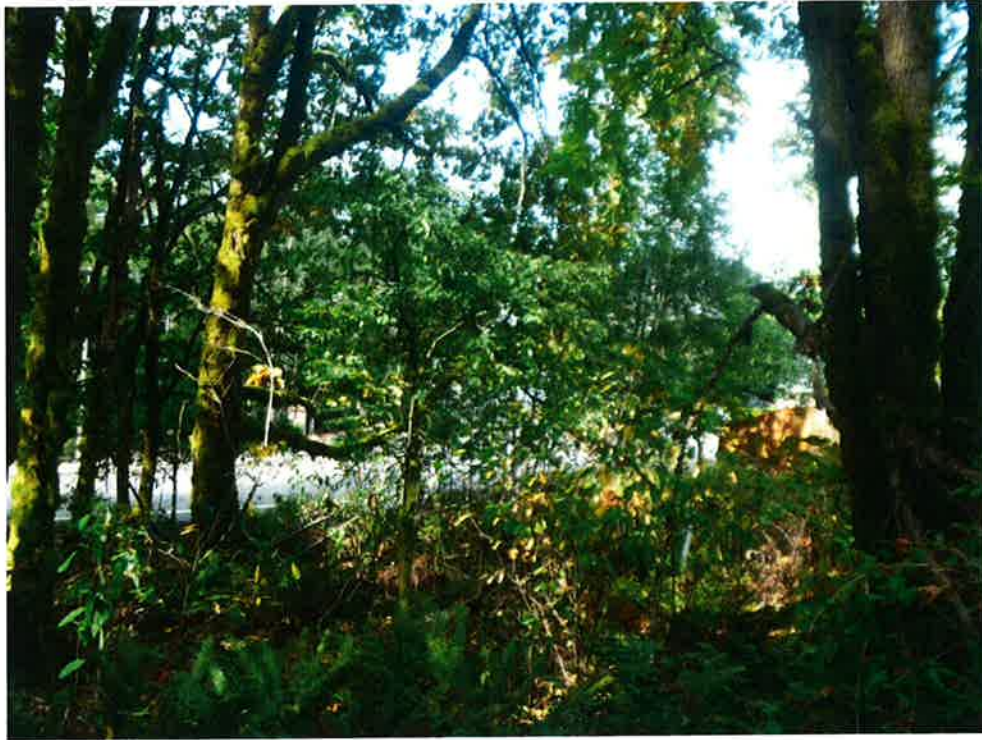
Figure 4: Approximate location of proposed residence (looking towards northwest corner of parcel).

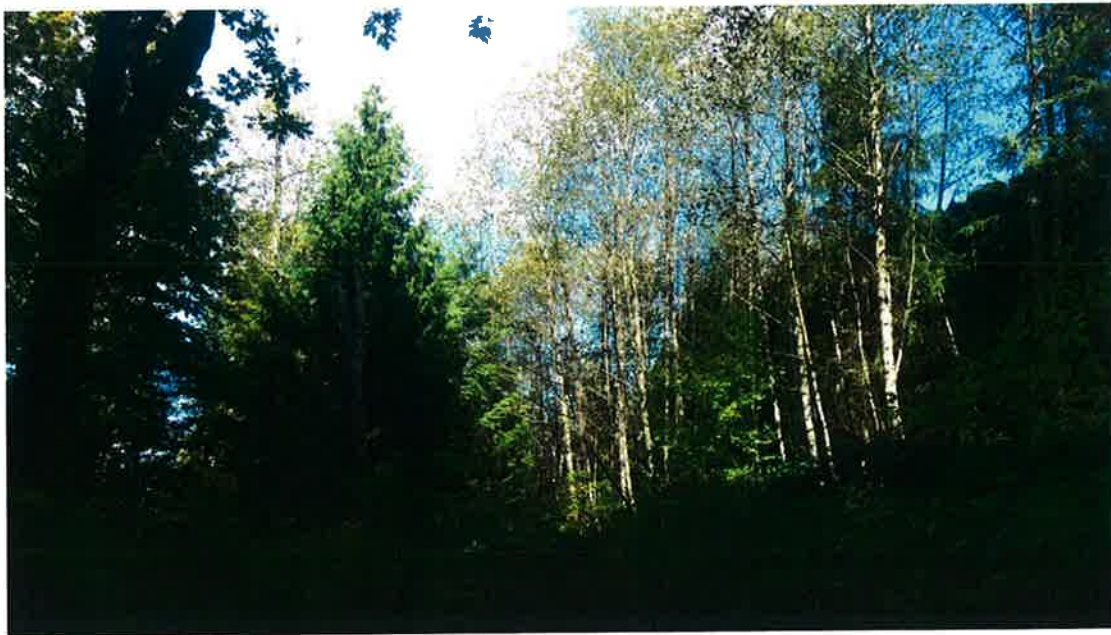
Figure 5: Vegetation conditions on site.

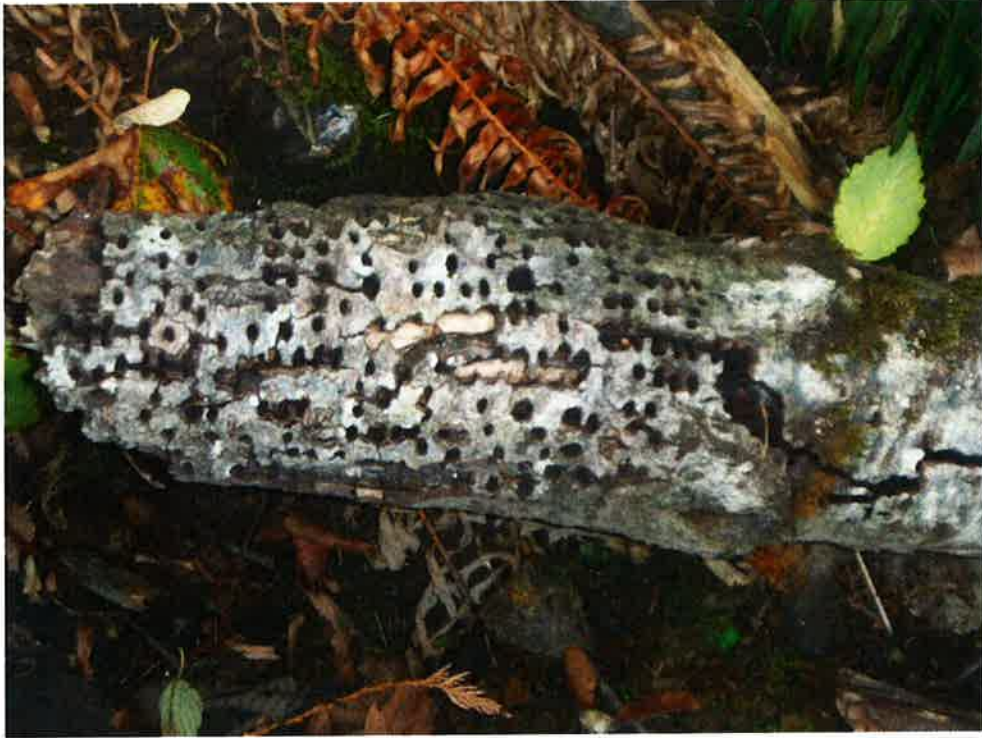
Figure 6: Evidence of woodpecker foraging on site.

Habitat features in the wetland and stream areas include water-holding features, a recent nest, small to large snags (DBH 10-30), and downed wood. Species sign observed in the wetland and along the stream include woodpecker signs on snags and logs (ex. Figures 6 and 9) and a recent birds nest (robin-sized, see Figure 8).

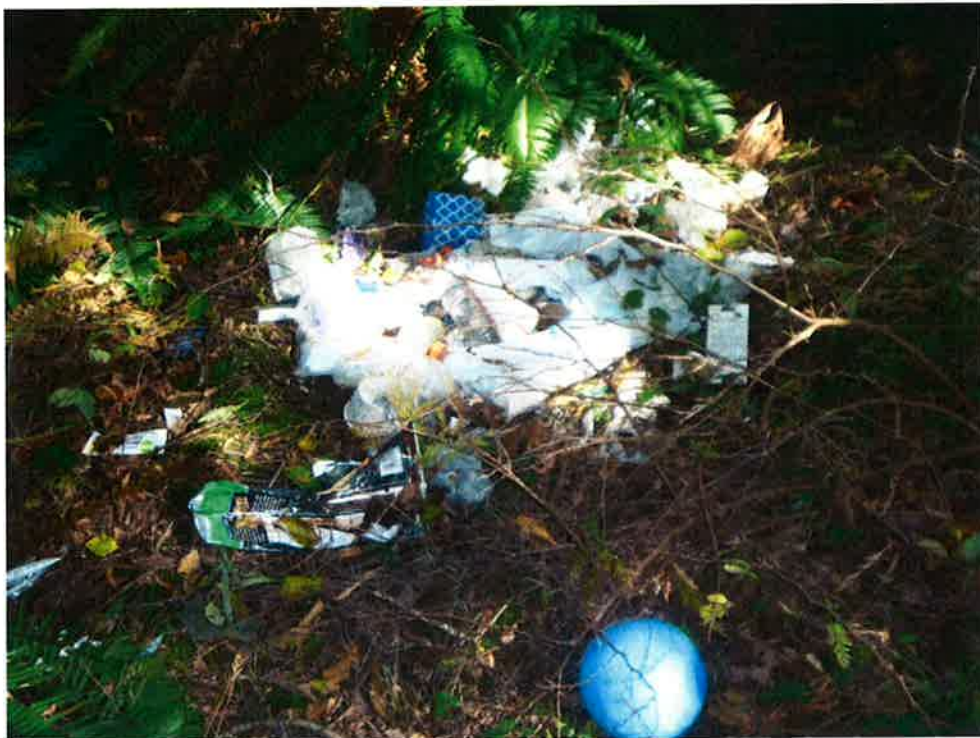
Figure 7: Trash disposed on site.

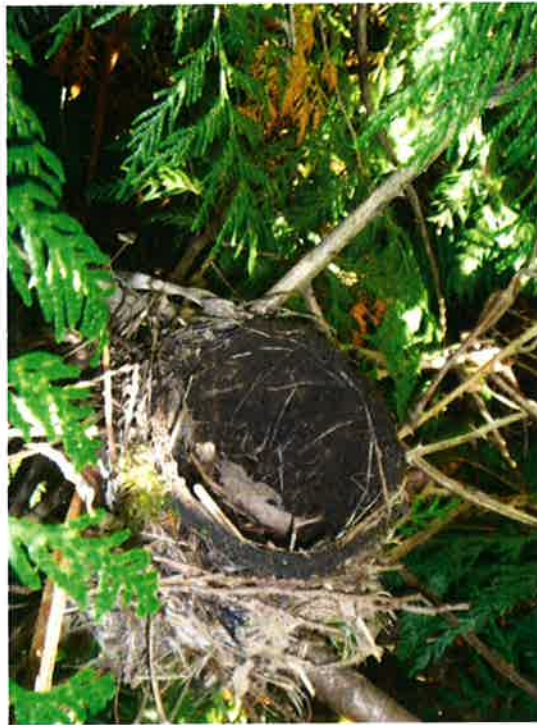
Figure 8: Empty bird nest documented on site.

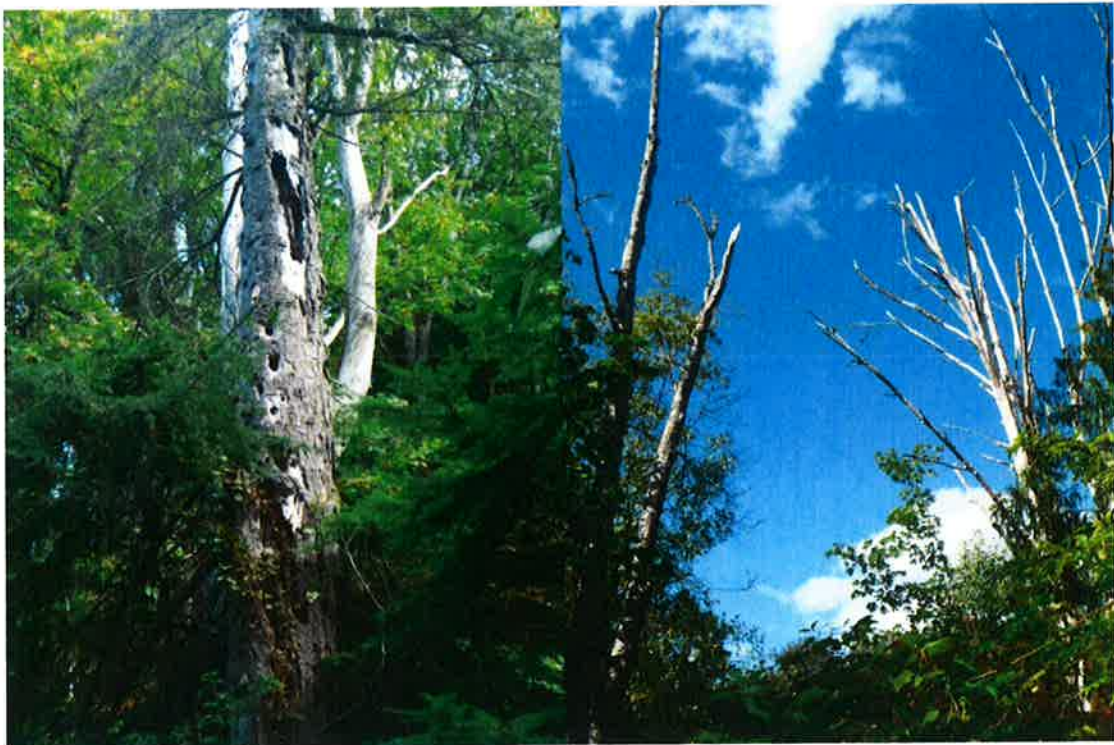
Figure 9: Snags documented on site.

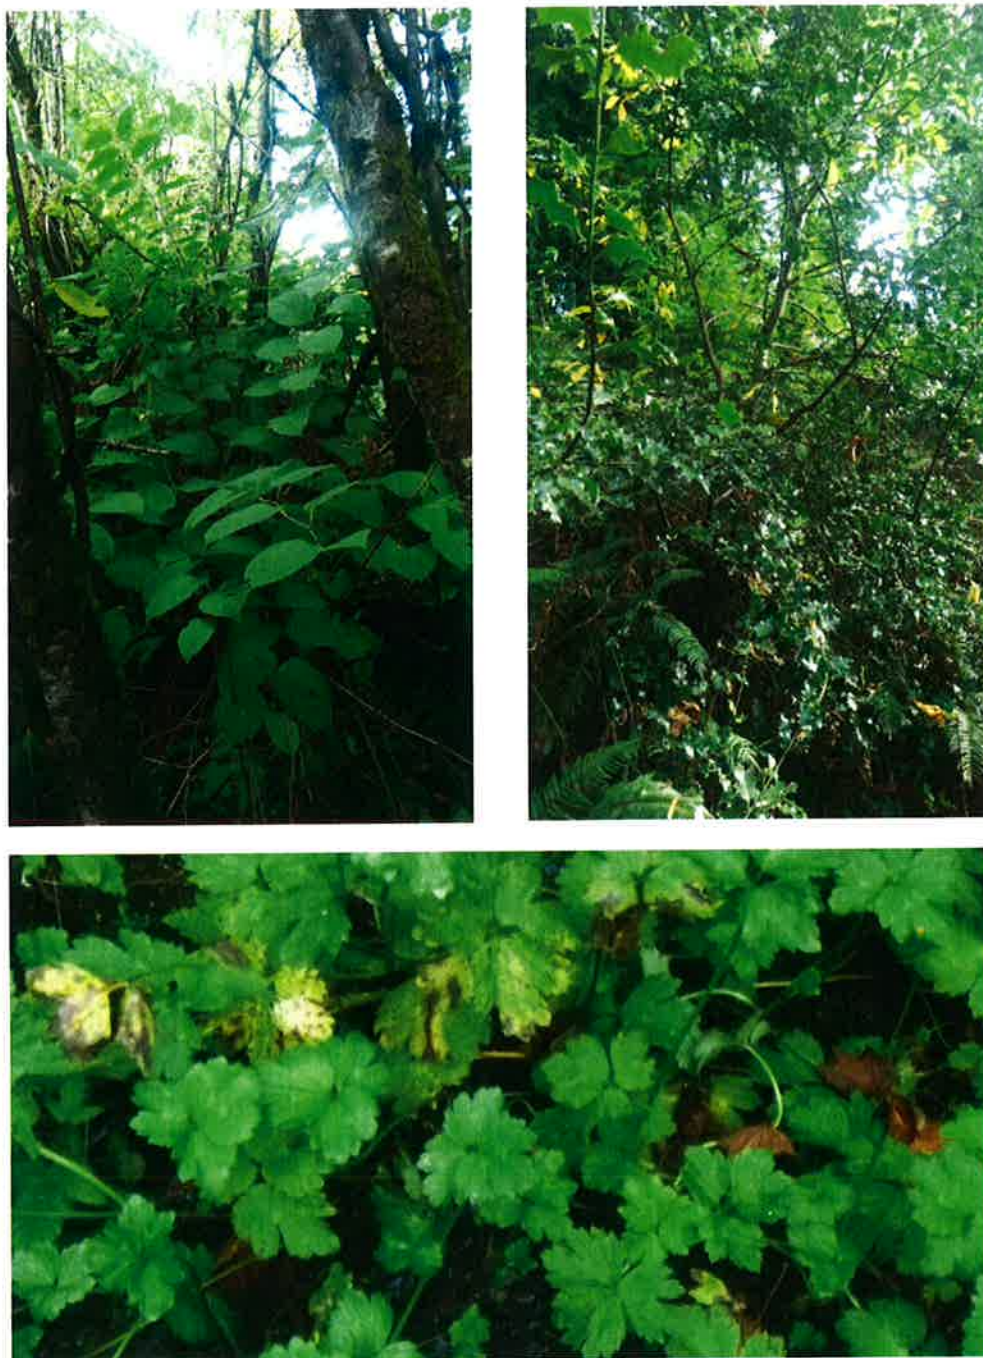
Figure 10: Invasive weeds documented on site. Top left: knotweed documented in wetland area. Top right: English holly documented throughout site. Bottom: creeping buttercup documented primarily in wetland area.

The proposed project includes enhancement of wetland and wetland buffer area (which also overlaps with the toe-of-slope setback) to compensate for the 1,347 feet of setback impact proposed. Knotweed areas are concentrated in the wetland area and wetland buffer. All knotweed areas will be removed and controlled. The area of knotweed is estimated to be approximately 7,600 square feet in size. In order to ensure knotweed eradication is maintained over time, native trees and shrubs will be installed to replace knotweed after removal is complete. The wetland has a distinct outflow point, which indicates that there is a potential for knotweed to spread downslope. Removal of knotweed from the wetland area will serve to prevent further spread of knotweed to downslope areas.

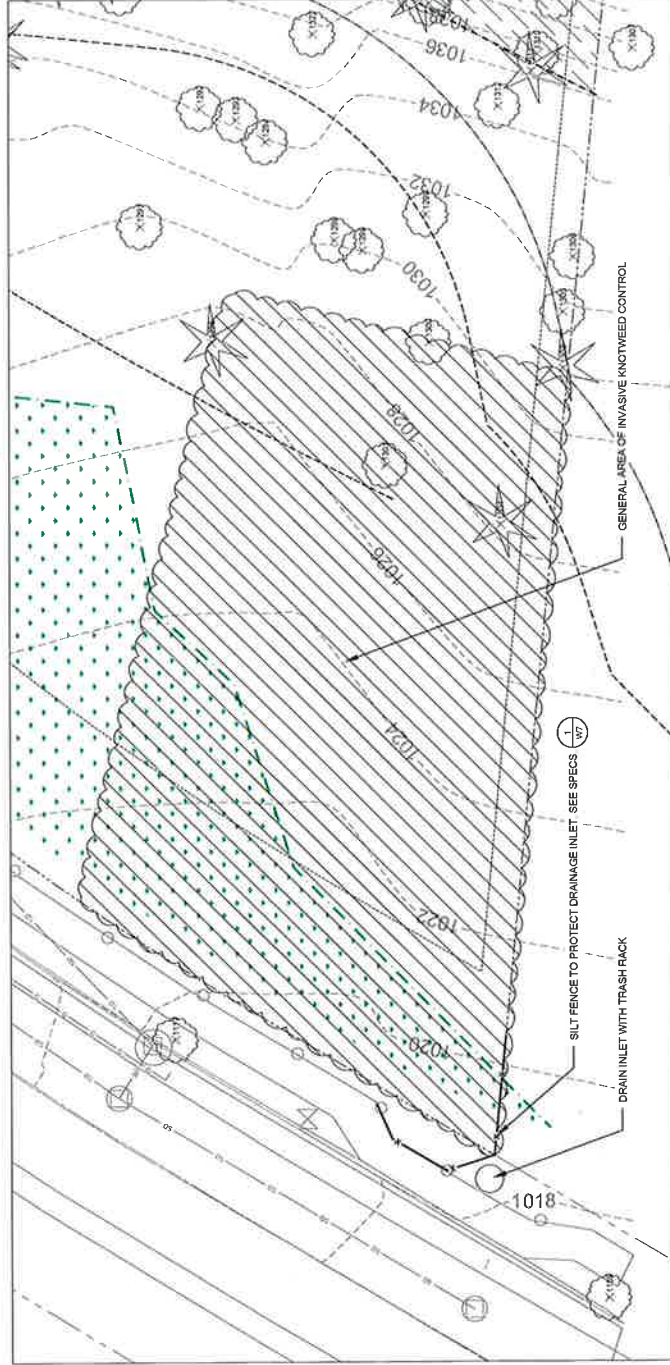
WETLAND BUFFER RE-VEGETATION PLANTING SCHEDULE AND TYPICAL

TREES / MINIMUM SPACING @ 10' O.C.	QTY	SIZE
PSEUDOTSUGA MENZIESII / DOUGLAS FIR	15	2 GAL
ALNUS RUBRA / RED ALDER	15	2 GAL
THUJA PLICATA / WESTERN RED CEDAR	15	2 GAL
ACER MACROPHYLLUM / BIGLEAF MAPLE	15	2 GAL
SHRUBS / MINIMUM SPACING @ 5' O.C.		
CORYLUS CORNUTA / EBANEK HAZELNUT	45	1 GAL
OEMLERIA CERASIFORMIS / OSC BERRY	45	1 GAL
RUBUS SPECTABILIS / SALMONBERRY	45	1 GAL
GROUND COVER / MINIMUM SPACING @ 24" O.C.		
POLYSTICHUM MUNITUM / SWORD FERN	300	4" INCH POT

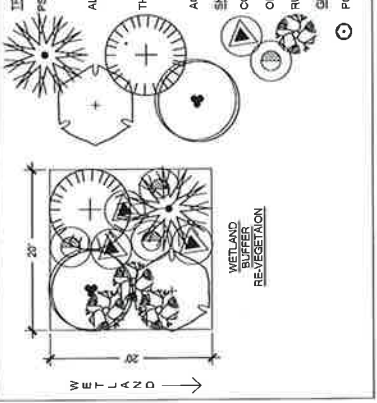
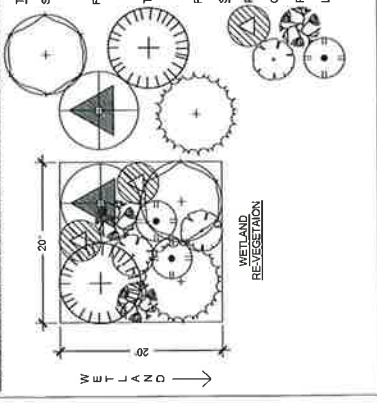
WETLAND RE-VEGETATION PLANTING SCHEDULE AND TYPICAL

TREES / MINIMUM SPACING @ 10' O.C.	QTY	SIZE
SALIX LASIANDRA / PACIFIC WILLOW	6	2 GAL
FRAXINUS LATIFOLIA / OREGON ASH	6	2 GAL
THUJA PLICATA / WESTERN RED CEDAR	6	2 GAL
PICEA SITCHENSIS / SITKA SPRUCE	6	2 GAL
SHRUBS / MINIMUM SPACING @ 5' O.C.		
RIBES LACINIAE / BLACK GOOSEBERRY	12	1 GAL
CORNUS SERICEA / RED-OSIER (RED TWIG) DOGWOOD	12	1 GAL
RUBUS SPECTABILIS / SALMONBERRY	12	1 GAL
LONGICERA INVOLUCRATA / BLACK THIMBERY	12	1 GAL

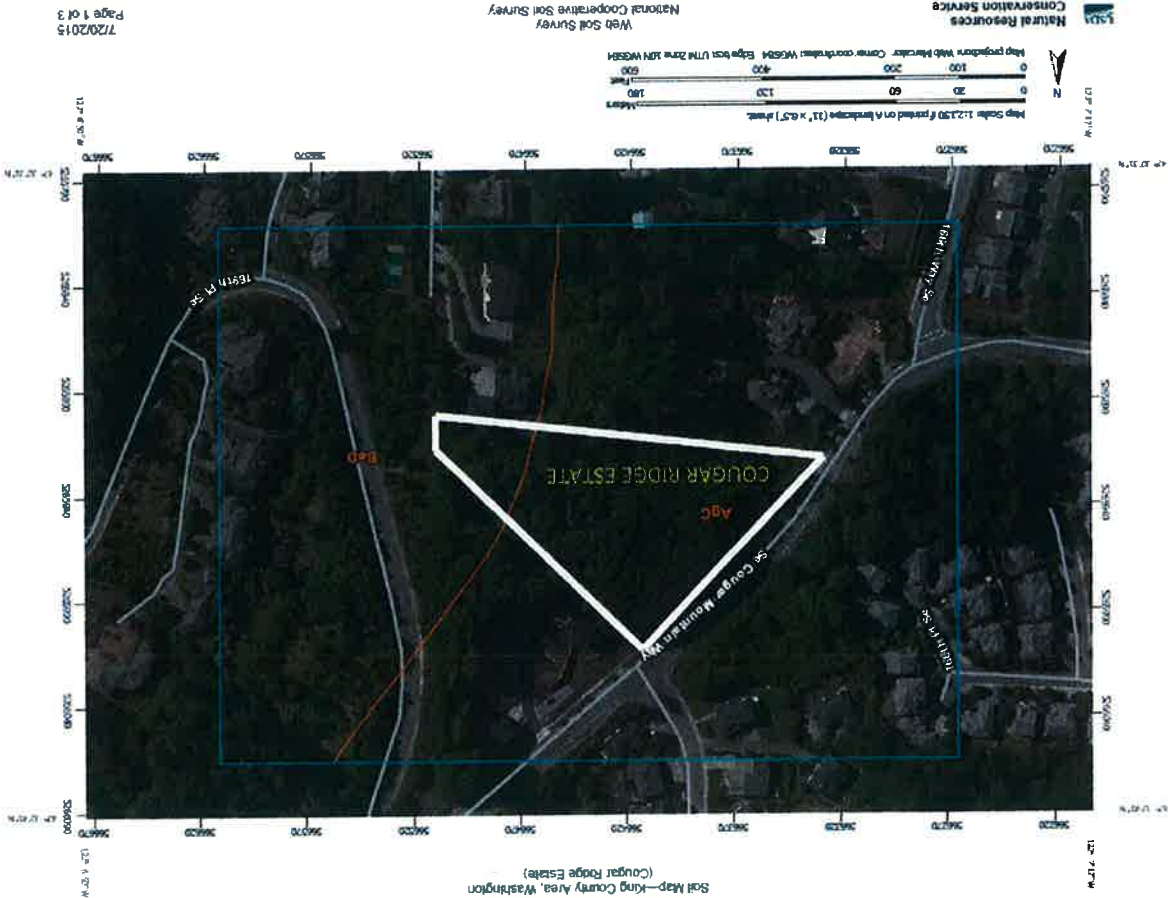
NRCS Soil Mapping (Excerpt)

The Natural Resource Conservation Service, NRCS, describe the soils across the property as being dominated by the Alderwood AgC and Beausite Bed. These gravely sandy loam soils are generally described on slopes with grades of 6 to 70 percent.

King County Area, Washington (WA633)			
Map Unit Symbol	Map Unit Name	Acres in AOI	Percent of AOI
AgC	Alderwood gravely sandy loam, 8 to 15 percent slopes	13.9	63.5%
Bed	Beausite gravely sandy loam, 15 to 30 percent slopes	8.0	36.5%
Totals for Area of Interest		21.8	100.0%
